Summary of Temescal Creek UAA as described in the January 12, 2012 Staff Report (Section 5.6.5. [UAA Analysis Temescal Creek](#) and [CDM UAA Technical Report for Temescal Creek](#))

Summary of UAA - Temescal Creek (Continued)

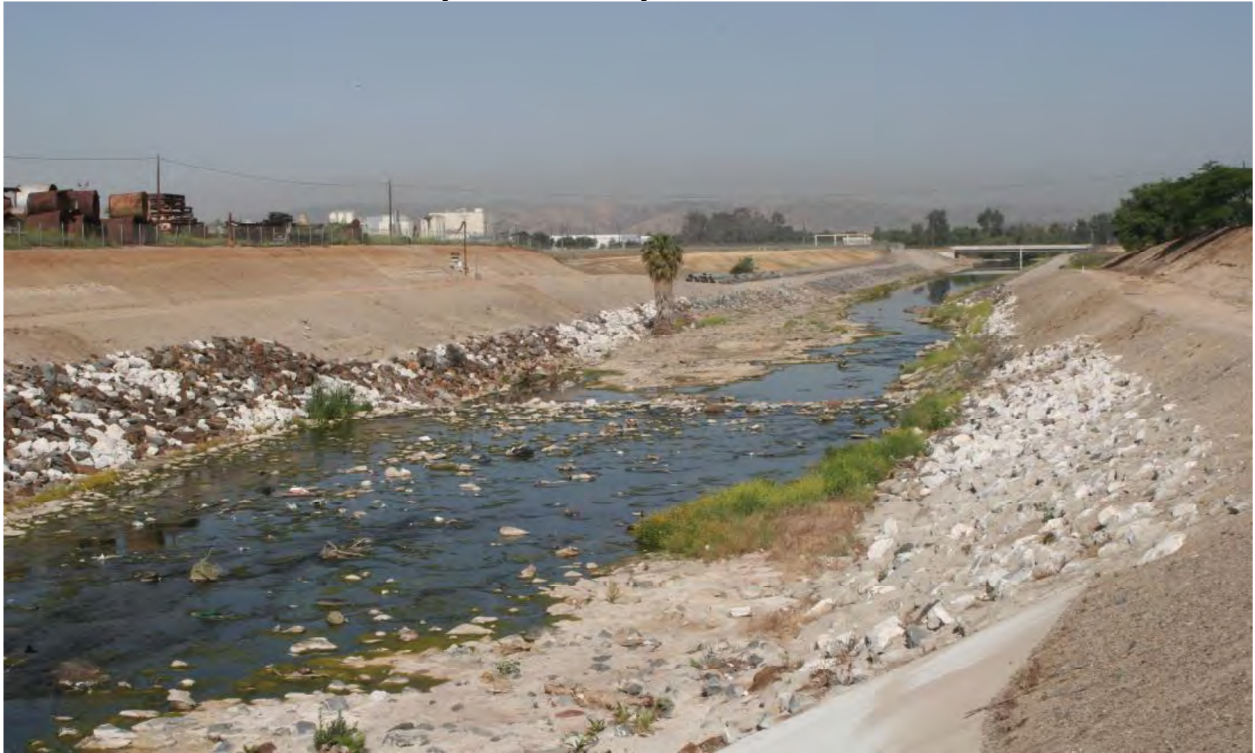
Figure TC-3. Temescal Creek, Reach 1a. This 0.5 mile long section, between Cota Street and Lincoln Ave, is the only earthen section of Reach 1a. (UAA Analysis TC)

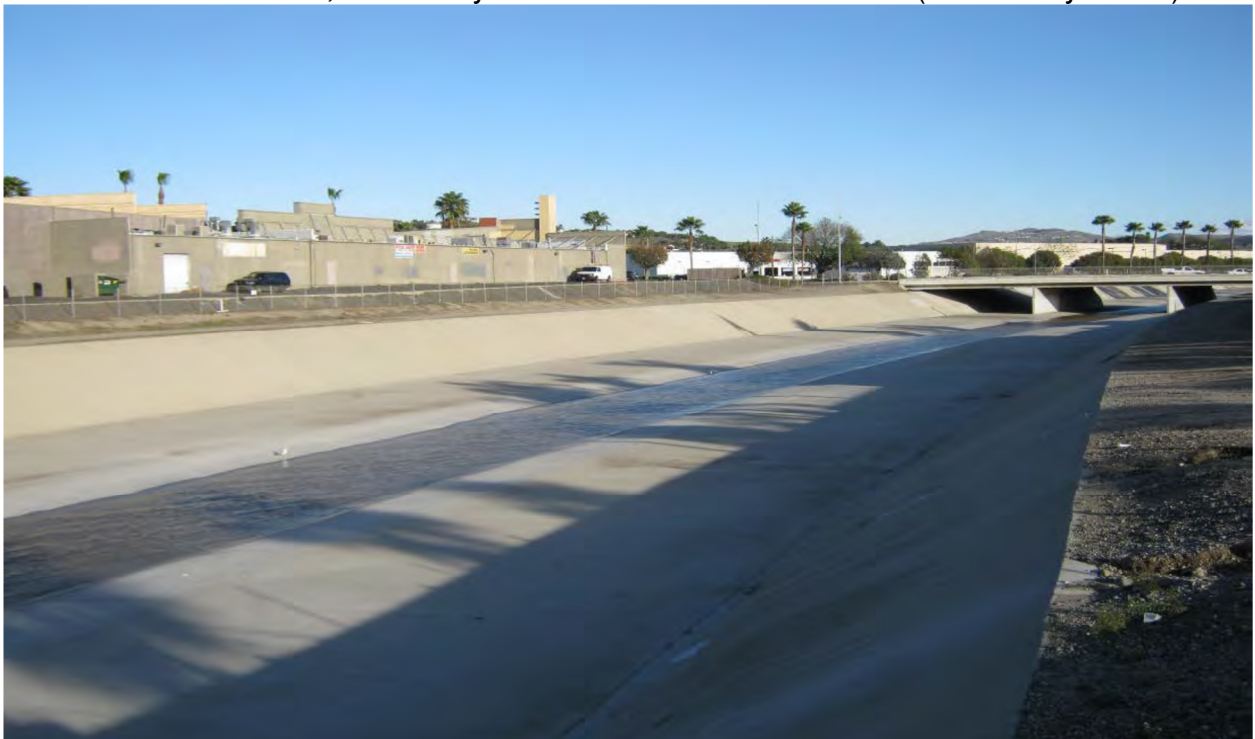
Figure TC-4. Temescal Creek, Reach 1a, looking upstream from Cota Street. This trapezoidal walled section of Reach 1a extends 3 miles. (UAA Analysis TC)

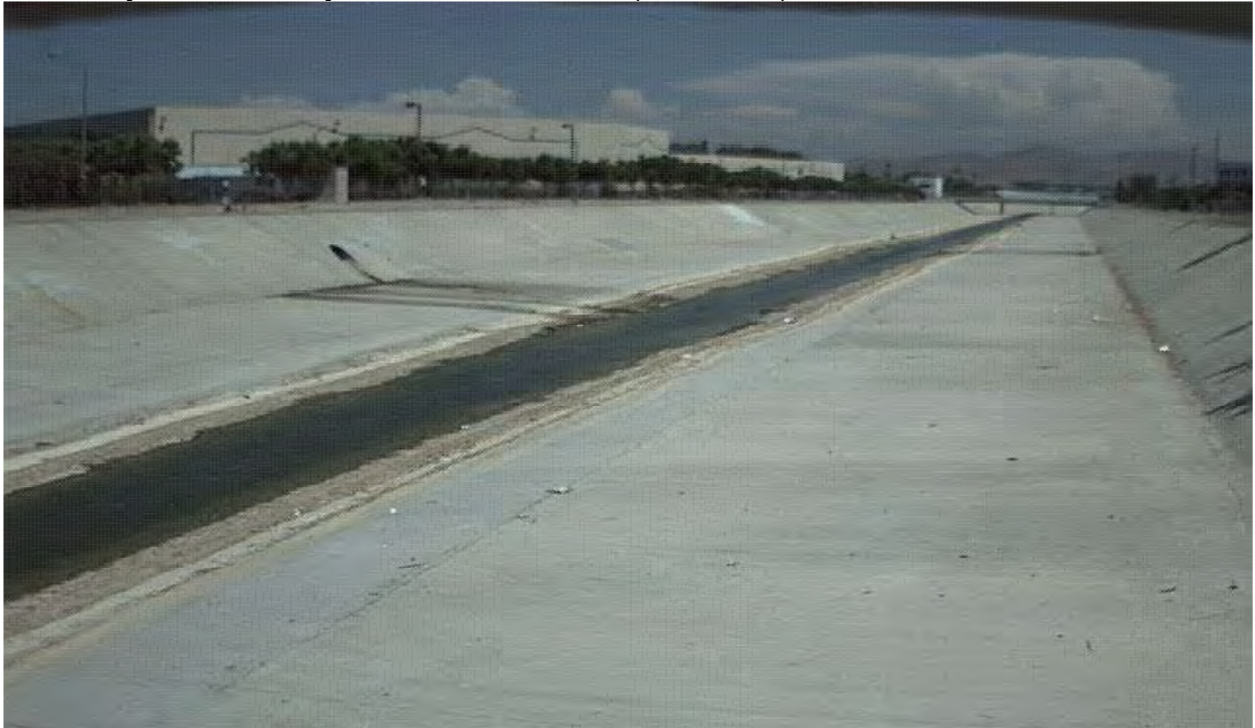
Figure TC-13. Reach 1a. Photo of the Camera View at the REC use survey location at Main Street. (UAA Analysis TC). REC1 use is not attainable; REC2 use is attained in Reach 1a.

Table TC-4 Recreation Use Survey Duration			
Survey Location	Start Date	End Date	Number of Images
Main Street	7/26/05	8/4/05	513
WWTP No. 2	11/1/05	11/1/06	10,653

Note that the camera at Main Street was vandalized beyond repair on the ninth day of operation.

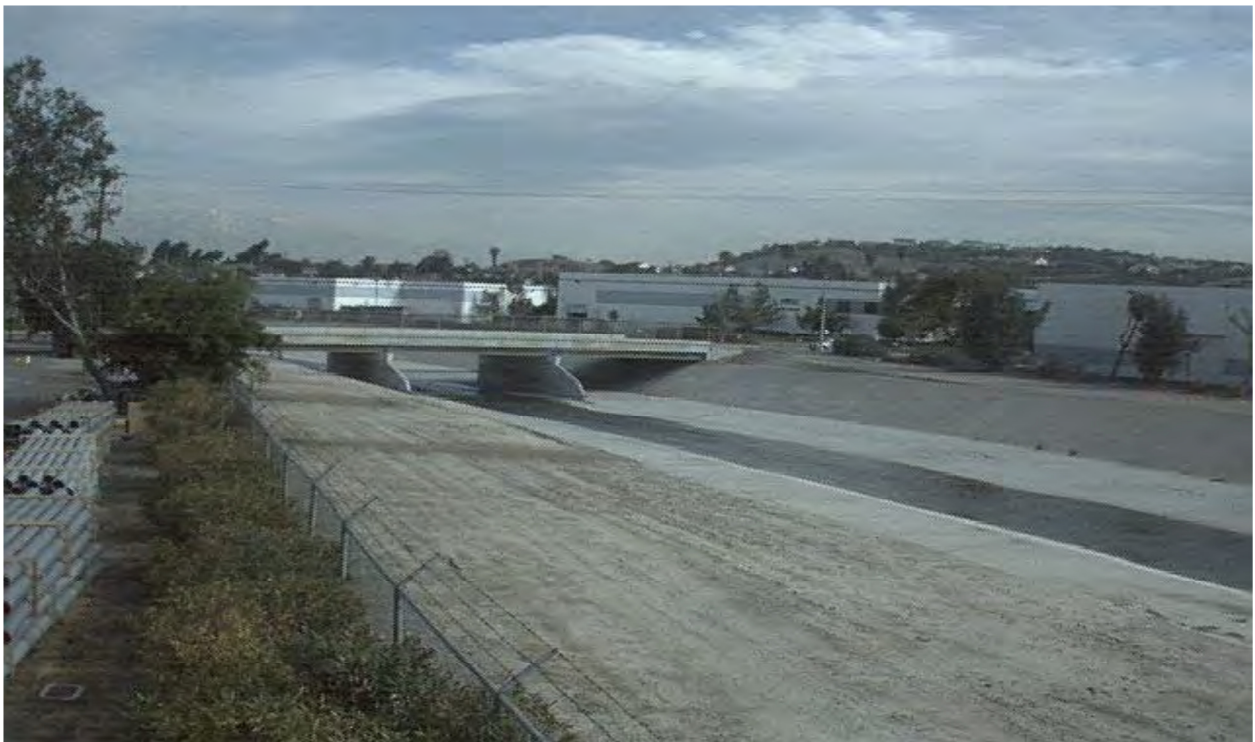
Figure TC-14. Reach 1a. Photo of the Camera View at the REC use survey location at City of Corona WWTP No. 2. Facing downstream. (UAA Analysis TC)

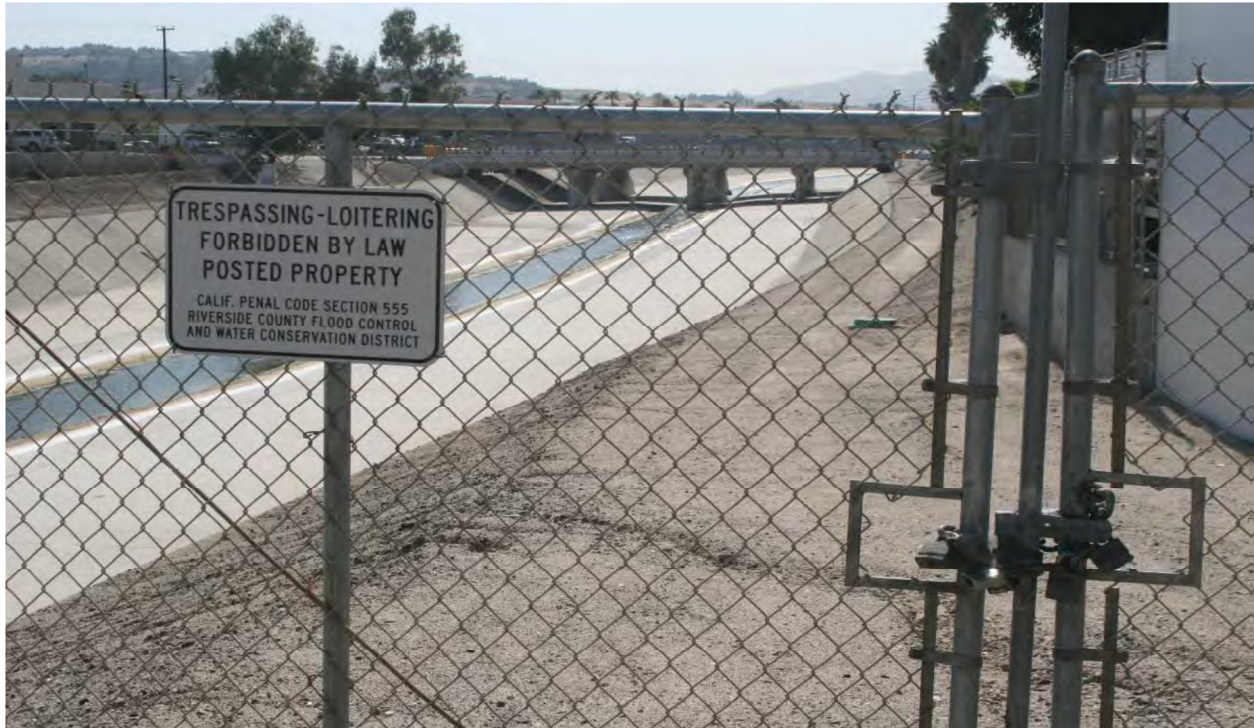
Figure TC-10. Reach 1a at Cota Street, City of Corona. Access is prohibited and the channel is fenced with locked gates in all areas of Reach 1a and 1b (UAA Analysis, TC)

- 1) **Access and Safety (Section 5.6.5 UAA Analysis TC, 5.6.5.5)**
 - a) **Reach 1a and Reach 1b: All fenced; maintenance access gates locked. (see Figure TC-10)**

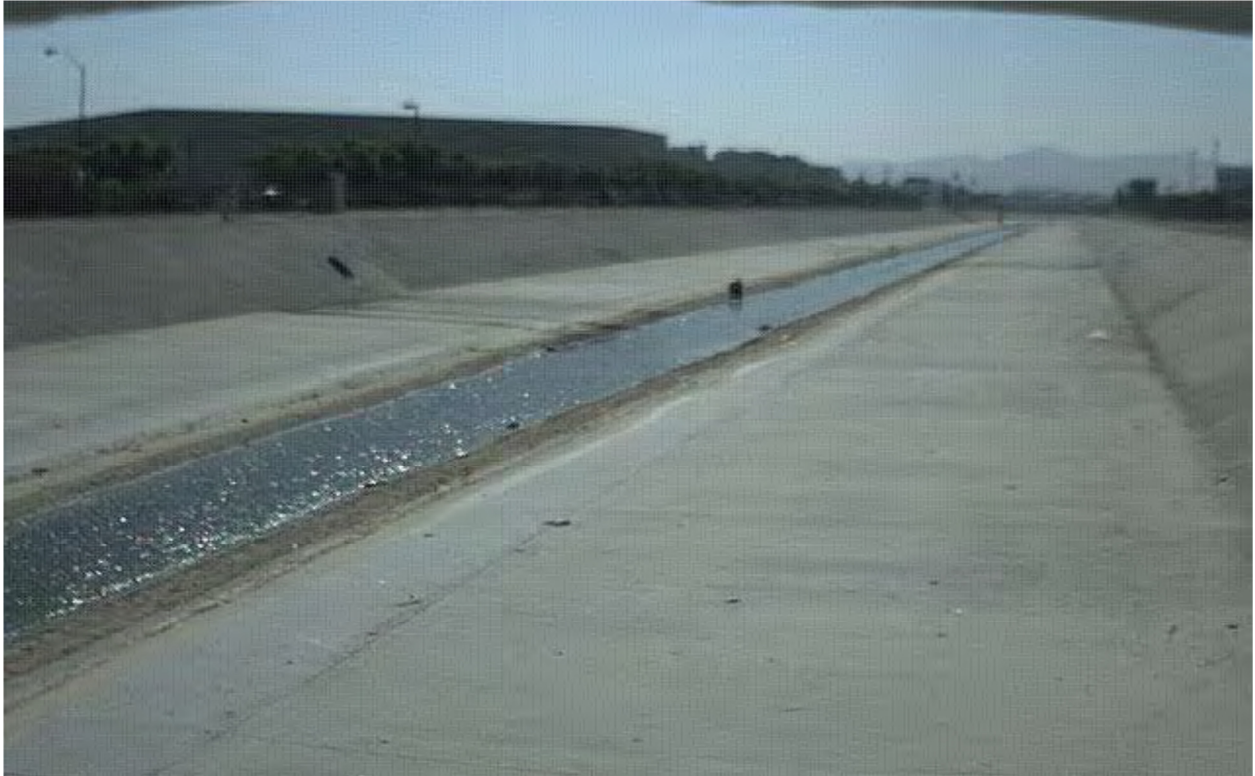
Figure TC-15. Reach 1a. Photo of Activity from the REC use survey camera location at Main Street in the City of Corona. Of the over 11,000 photos taken at the two REC survey photo locations in Temescal Creek Reach 1a, only two images, which includes this photo, show any possible water contact with individuals. (UAA Analysis, TC)

Conclusion: No photographic evidence of REC1 activity within Temescal Creek. There is evidence (31 images) of individuals walking/bicycling in Reach 1a section of the Channel, without water contact (e.g., see Figure TC-17). These individuals appear to be using the channel as a convenient access corridor. Of the 11,166 images recorded at the camera survey locations (Reach 1a), only two suggested any type of water contact; contact was limited to below ankle and short duration (less than 30 minutes) (e.g. see Figure TC-15).

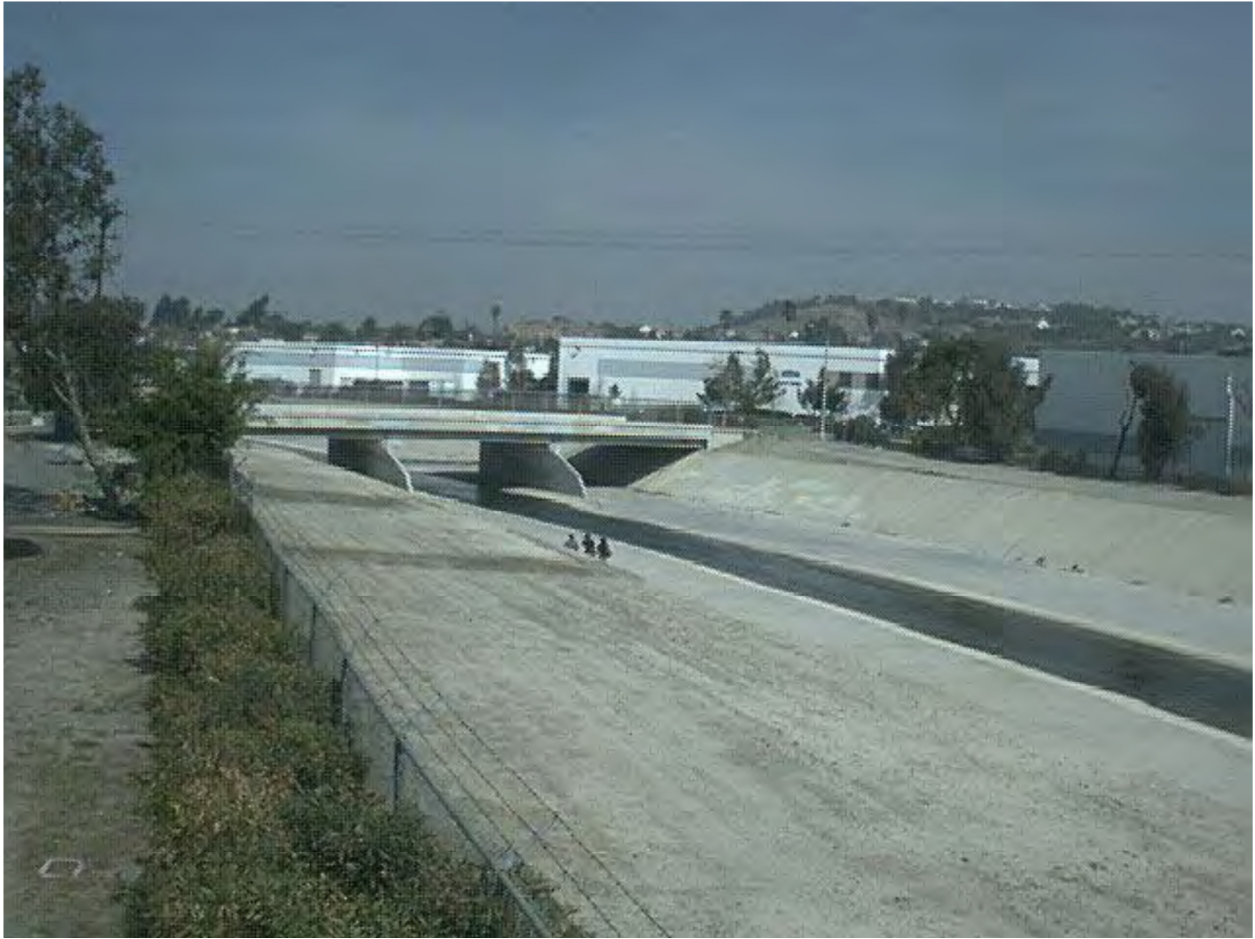
Figure TC-17. Reach 1a. Photo of Activity from the REC use survey camera location at City of Corona Waste Water Treatment Plant. This shows evidence of individuals walking/bicycling in Reach 1a section of the Channel, without water contact. These individuals appear to be using the channel as a convenient access corridor. As a result of this type of activity noted in the channel, the REC 2 use was designed for Reach 1a. The REC 1 use is not considered to have being attained. (UAA Analysis, TC)

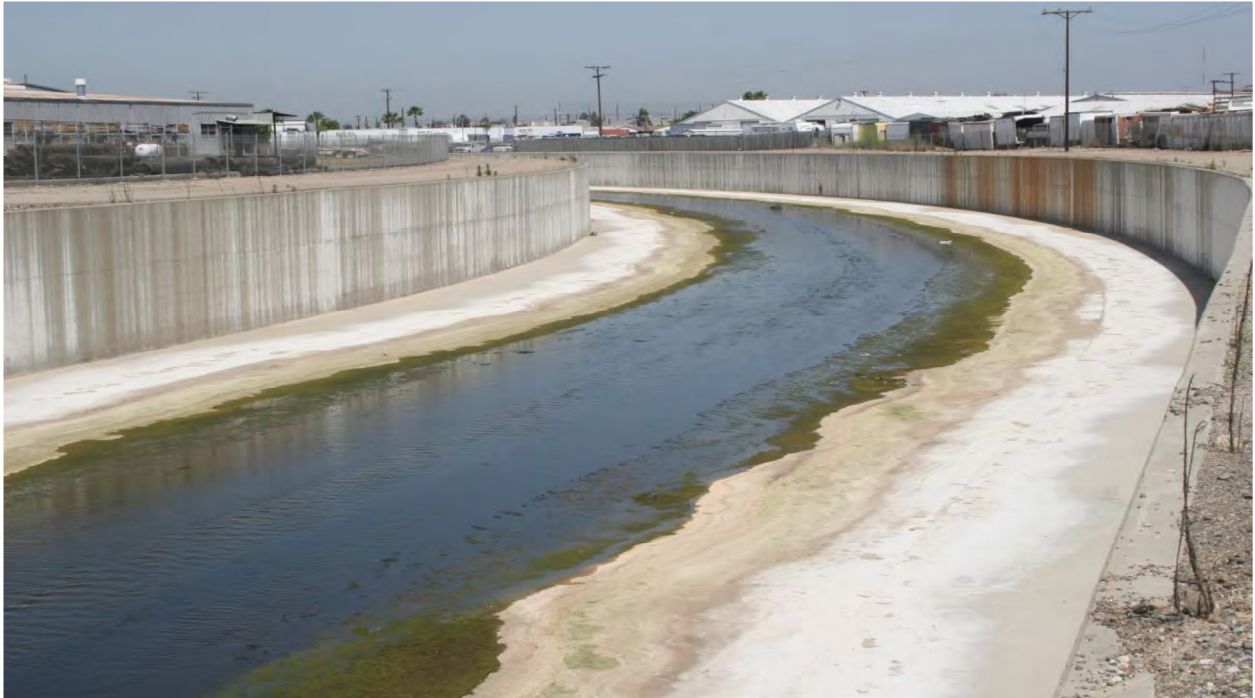
Figure TC-5. Reach 1b contains 14 ft. high vertical walls with a bottom width of 84 ft. and is approximately 3 miles in length. REC1 and REC2 uses are not attainable in Reach 1b. (UAA Analysis TC)
